# Read Me

## System Software 7.4.1 PATCH 9

This version of our system software is available for the following gateways:

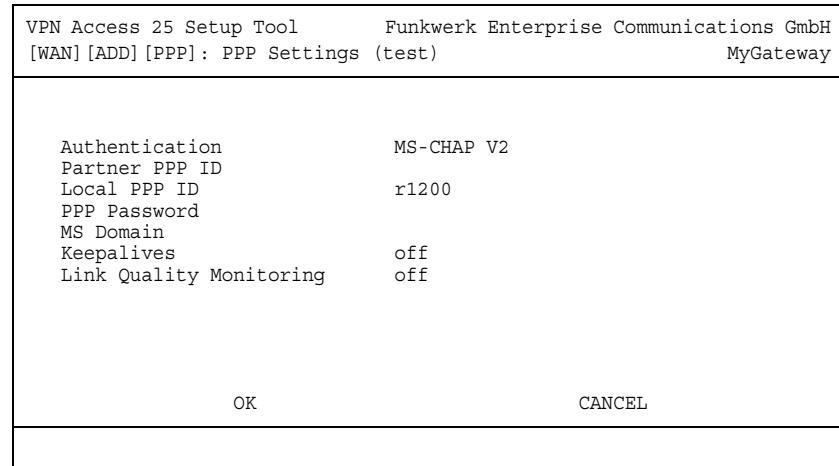
The authentication negotiation between Windows clients and the router sometimes failed for PPP or PPTP connections if the login name was used together with the domain name, for example, DEVELOPMENT\Developer.

In MS-CHAP V1 the entire identification name (domain and login name) is used for authentication.

In MS-CHAP V2 only the login name is used for authentication. The domain name is checked separately. To do so, the domain name must be entered in the new **MS DOMAIN** field. The field is only shown if **AUTHENTICATION = MS-CHAP, MS-CHAP V2 or CHAP + PAP + MS-CHAP**.

The problem has been resolved.
