# Release Notes

## System Software 10.2.12 Patch 2

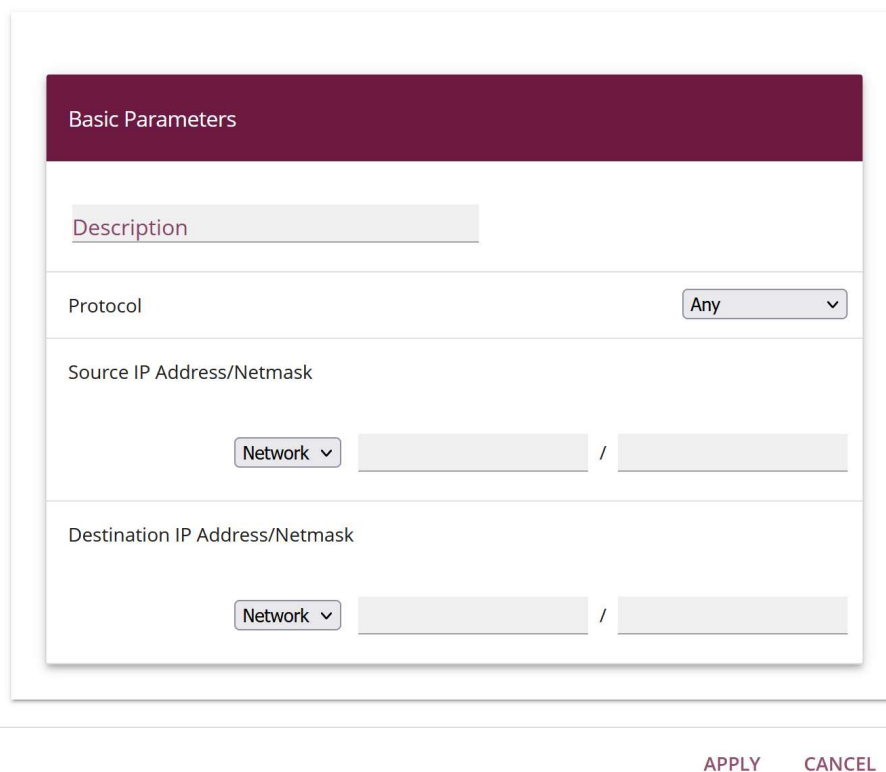
It is useful to specify the traffic that should be sent over the tunnel as precisely as possible. To do this, you can narrow down the destination and source networks in the **VPN > IPSec > IPSec peers > Edit > Additional filter of IPv4 traffic** menu:

In this menu, make sure that the networks connected via the tunnel include all IP addresses that should have access to the remote network, and likewise all addresses that should be reached there.

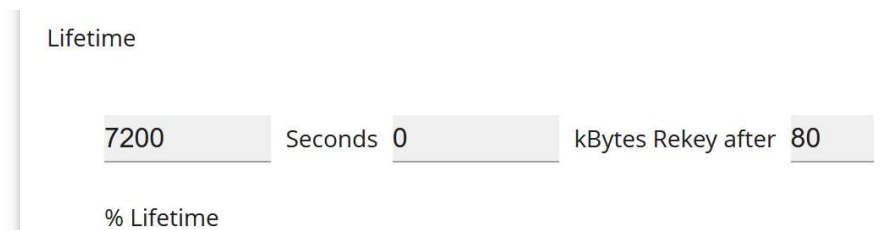
- **Internet & Network > VPN > IPsec > Phase-2-Profiles > Edit**

Lifetime

7200      Seconds 0      kBytes Rekey after 80
